TECHNICAL NOTE No. M.E. 382

This Note records the results of a number of static and dynamic detonations of 3/16 and 1/4 inch square-section continuous rod (C.R.) warheads against Boeing "B.29", Vickers "Valiant", Handley Page "Victor" and some replica steel fuselage sections, most of which were either loaded to simulate straight and level flight conditions during attack and/or were subsequently loaded to determine residual strength. Rod effectiveness was found to depend, for all the targets, on the direction of rod approach to, and the construction of, the section attacked but at least for the 3/16 inch C.R., appeared to be independent of rod impact velocity in the range 3000 to 5000 f.p.s.

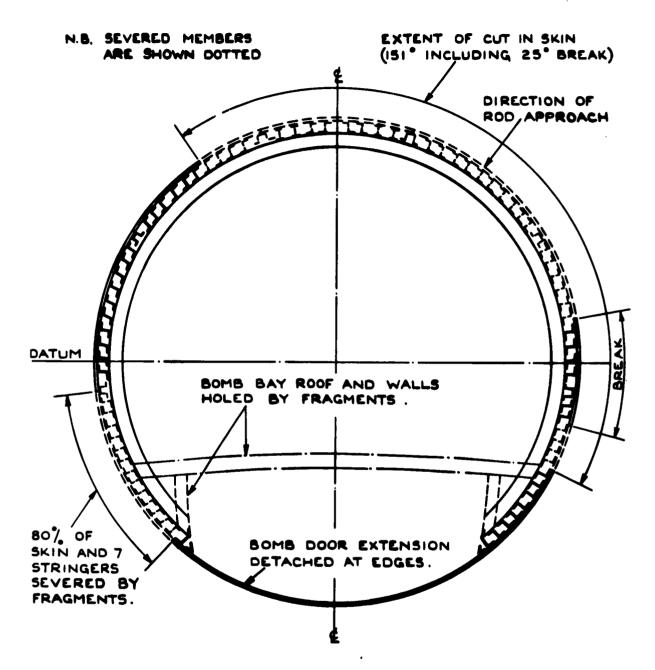
FIG. 3.

RESULT: FUSELAGE SECTION ATTACKED IN THE '19' LOADED CONDITION, FAILED ON ATTACK.

STN. 963 OF LOADED VALIANT 673' FUSELAGE

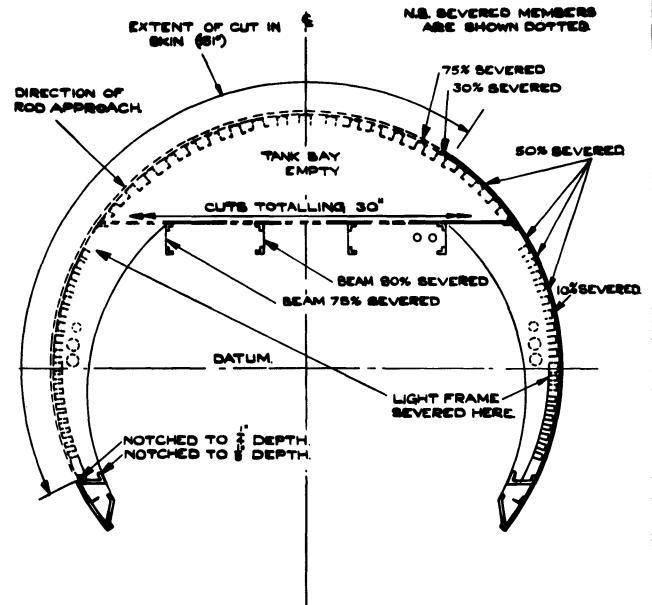
FIG. 3. TARGET IA. RECORD OF ROD DAMAGE TO 'VALIANT TYPE 673' FUSELAGE . (1/4 IN. ROD. LOW VEL.)

RESULT: FUSELAGE SECTION ATTACKED IN THE UNLOADED CONDITION. FUSELAGE FAILED UNDER SUBSEQUENT APPLICATION OF LOAD. EQUIVALENT TO 0:944.

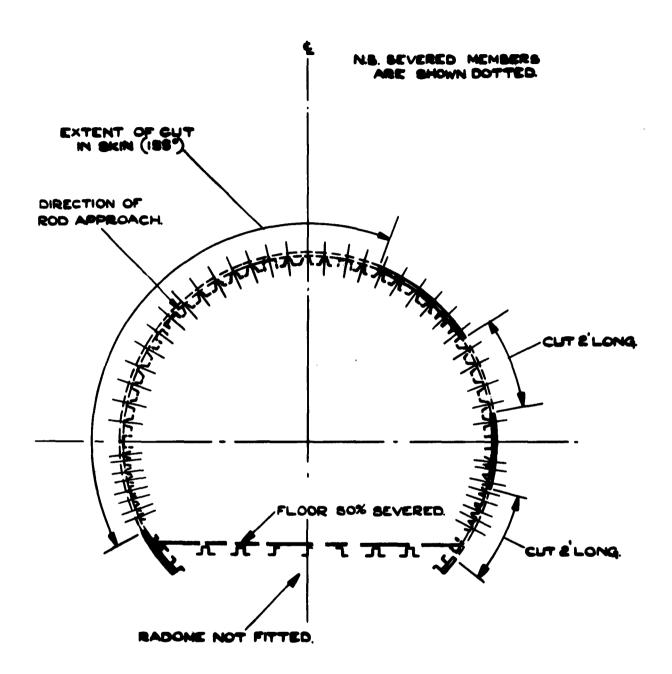
FIG.4. TARGET IB. RECORD OF ROD DAMAGE TO 'VICTOR' FUSELAGE (4 IN. ROD. LOW VEL.)

STN. 940 OF UNLOADED 'VICTOR' FUSELAGE.

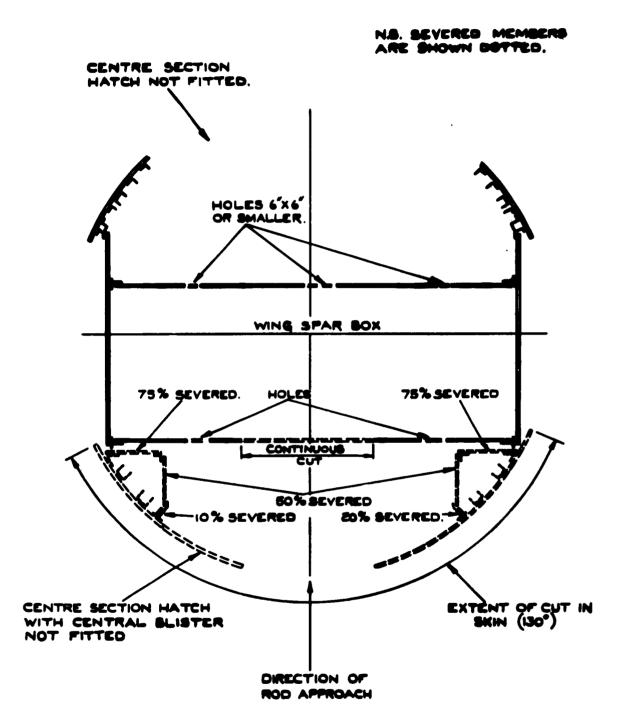
FIG. 6. TARGET 7A. RECORD OF ROD DAMAGE TO 'B29' TARGET (4 IN. ROD. LOW VEL.)

STN. 434 OF UNLOADED B. 29 FUSELAGE.

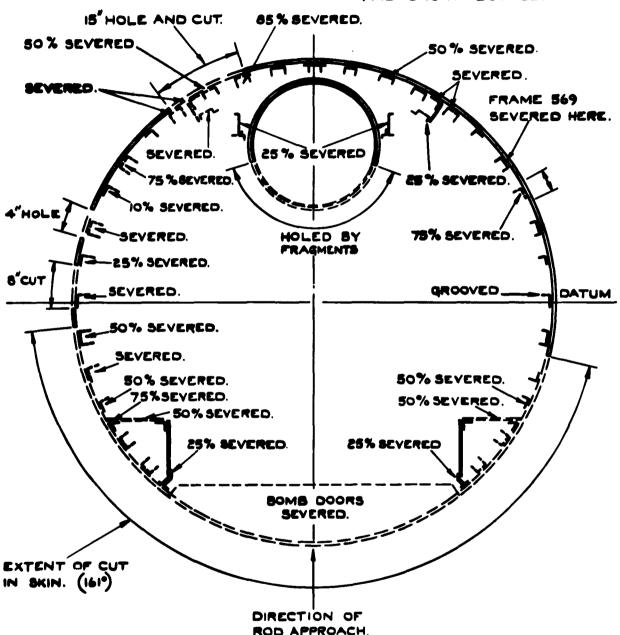
N.B. SEVERED MEMBERS ARE SHOWN DOTTED.

RESULT: FUSELAGE SECTION ATTACKED IN THE UNLOADED CONDITION, DID NOT FAIL UNDER SUBSEQUENT APPLICATION OF 11, 160,000 LB. IN. BENDING MOMENT EQUIVALENT TO '8:39' LOADING.

FIG. 9. TARGET 3B. RECORD OF ROD DAMAGE TO B. 29' TARGET. (3/16 IN. ROD. HIGH VEL.)

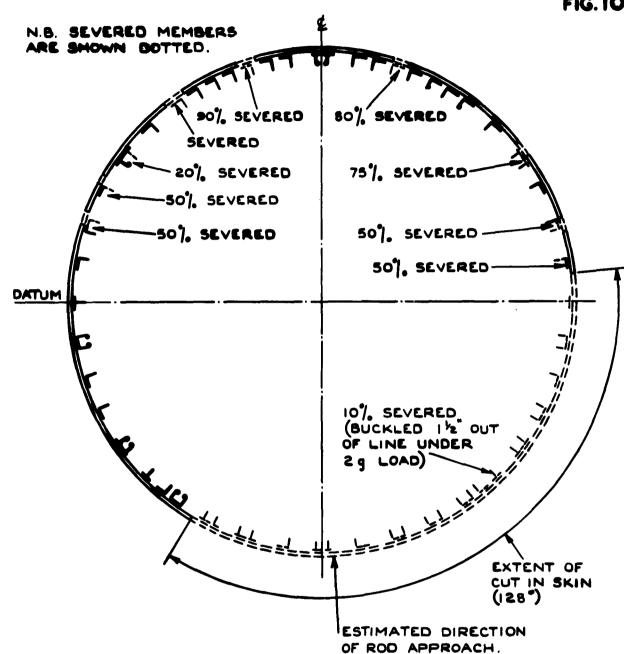
RESULT :- FUSELAGE SECTION ATTACKED IN THE 'IG' LOADED CONDITION. DID NOT FAIL AFTER APPLICATION OF 4,700,000 LB.IN. BENDING MOMENT EQUIVALENT TO '2 g' LOADING.

FIG. 10. TARGET 3 A. RECORD OF ROD DAMAGE TO 'B. 29' TARGET. (3/16 IN. ROD. HIGH VEL.)

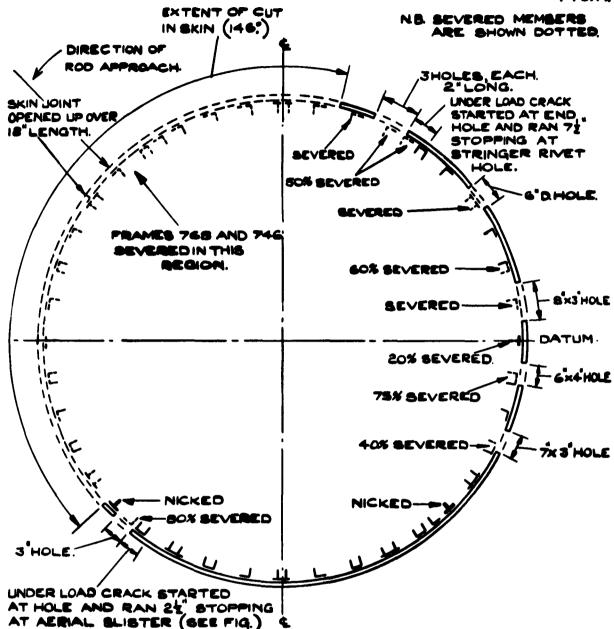
RESULT: FUSELAGE SECTION ATTACKED IN THE UNLOADED CONDITION. DID NOT FAIL UNDER SUBSEQUENT APPLICATION OF 4,990,000 LB.IN. BENDING MOMENT EQUIVALENT TO 2-14 LOADING.

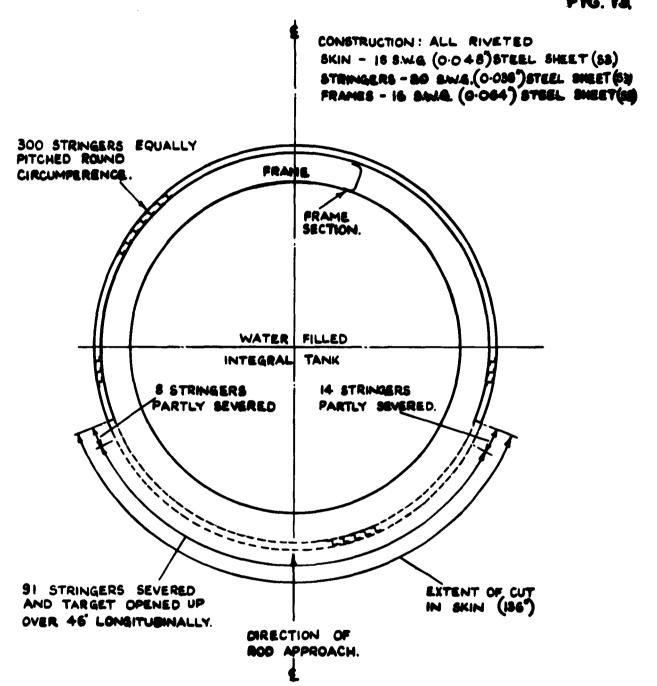
SKIN TORN AND CRACKED

> STN. 768 OF B 29 FUSELAGE. NOTE STRINGERS (CLE OF FIG. 28 NOT PRESENT IN THIS TARGET.

FIG. 12. TARGET 5 A. RECORD OF ROD DAMAGE TO 'B 29' TARGET. (% M. ROD. HIGH VEL.)

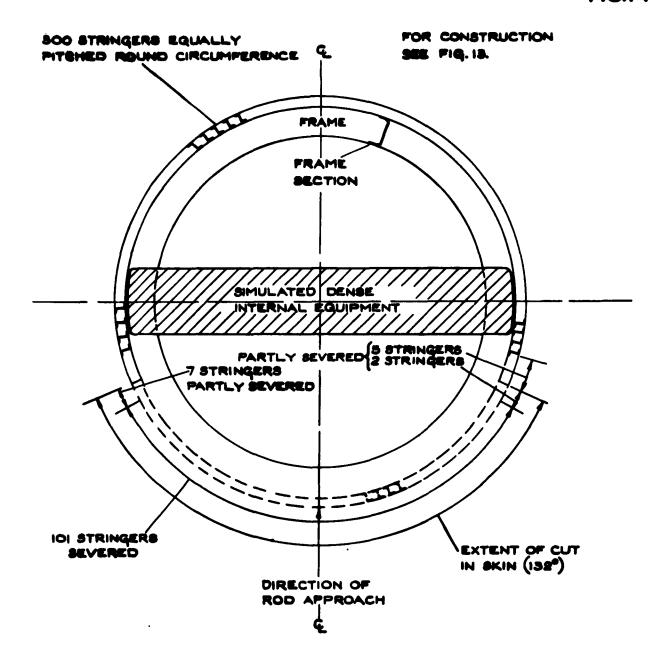
FIG. 13. TARGET 4B. RECORD OF ROD DAMAGE TO 'S.S.I.'
REPLICA STEEL FUSELAGE SECTION. (3/61N.ROD.HIGH VEL.)

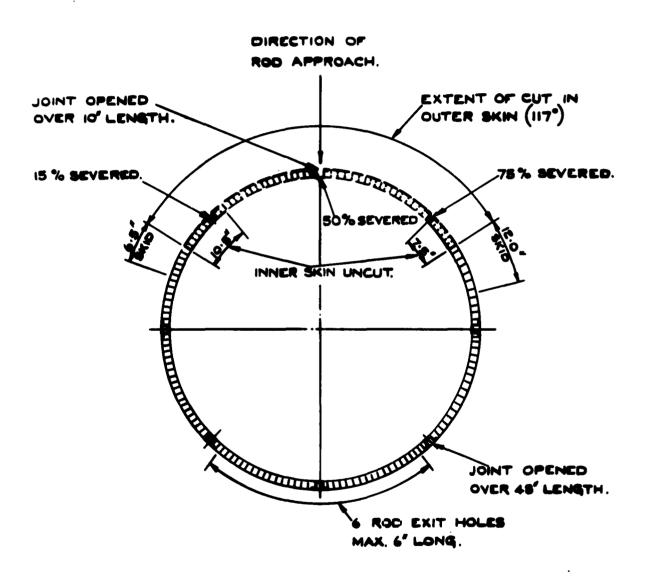
CONSTRUCTION: BRAZED HONEYCOMB SANDWICH.
SKINS - 18.8.W.Q. STAINLESS STEEL (REX.448)
CORE - 0.003" MILD STEEL
JOINT STRINGERS - 16.8.W.Q. DT.D.171.

MID-LENGTH OF STEEL HONEYCOMB SANDWICH TARGET.

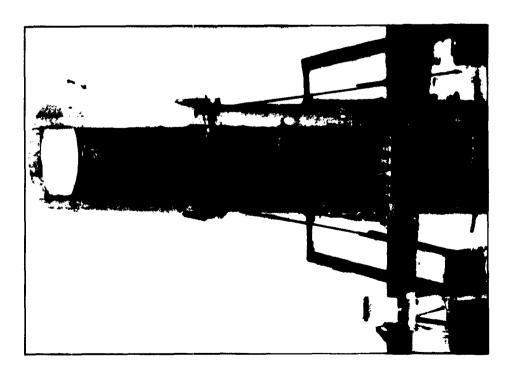
FIG.21s. TARGET 2. UNLOADED "B.29" AFT BOMB BAY SECTION BEFORE ATTACK

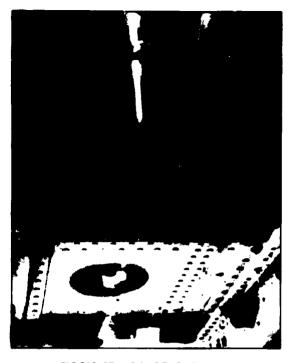
FIG.21e. to h. TARGET 2. ROD DAMAGE TO LONGERON STRUCTURE (LOW VEL. \(\frac{1}{4}\)in. ROD. STN. 566)

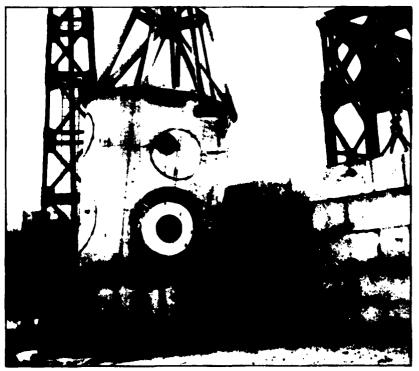
FIG.25b. TARGET 5a. FAILURE OF FUSELAGE UNDER SUBSEQUENT LOADING EQUIVALENT TO "1-8g"

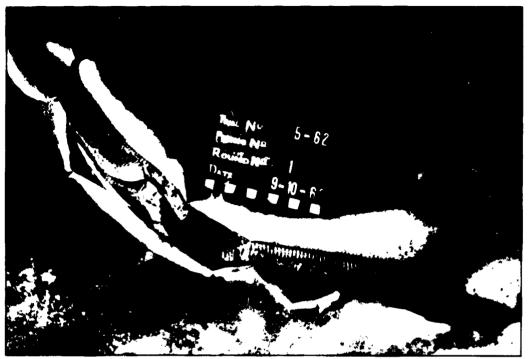
FIG.28c. TARGET 8. ROD DAMAGE TO HONEYCOMB CORE AND INNER SKIN (LOW VEL. 14 in. ROD)
